BOUNTIFUL CITY
TRAFFIC SAFETY COMMITTEE AGENDA
Wednesday, November 8, 2023
2:00 p.m.

Traffic Safety Committee Staff Report

Subject: Request for Stop Sign Installation at 1000 E / Center St Intersection
Author: City Engineer, Lloyd Cheney
Department: Engineering
Date: Nov. 8, 2023

Subject: Request for Sign Installation Eagle Ridge Dr (700 N-800 N)
Author: City Engineer, Lloyd Cheney
Department: Engineering
Date: Nov. 8, 2023

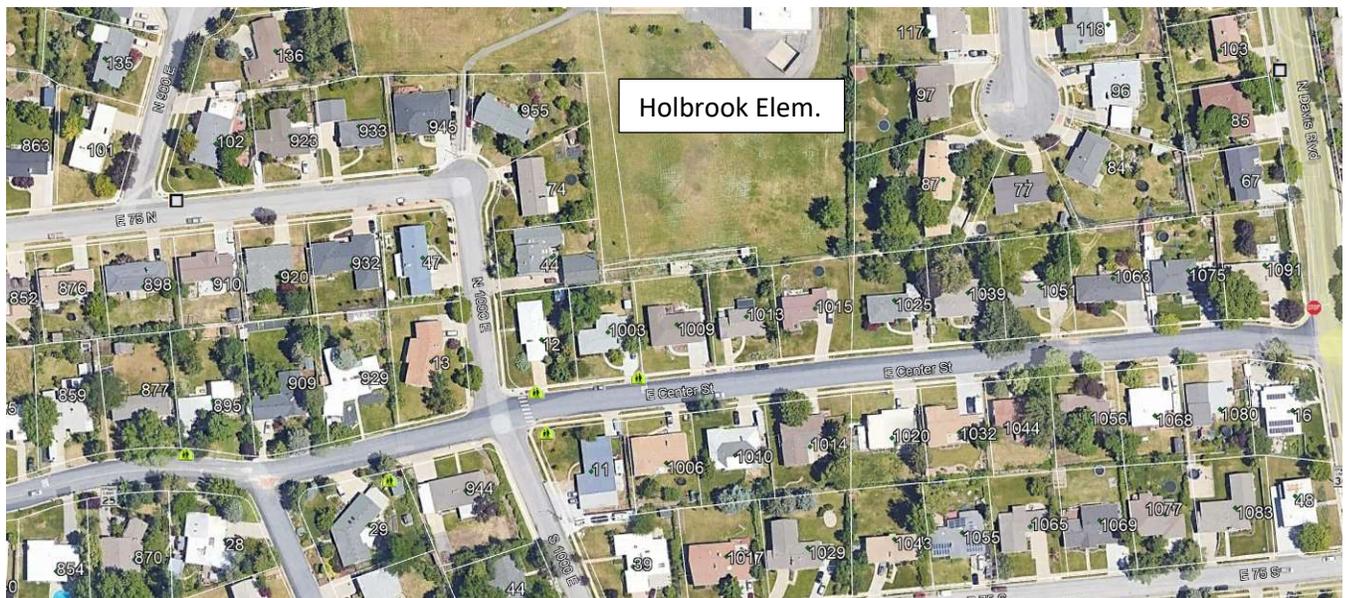
Figure 1 Center St. (from approx. 850 E to Davis Blvd) With existing signage

The intersection of Center St. and 1000 E is a standard 4 leg, perpendicular intersection. 1000 E St. on either side of the intersection slopes slightly to the North, with Center Street sloping down from East to West at approximately 8%. This configuration is similar to many intersections in the residential neighborhoods east of 400 E and Orchard Dr. Currently, there are no traffic control signs or devices in place to regulate traffic. Advance crossing signs and signs located at the crosswalk on the east side of Center St. are appropriately placed and are visible to the oncoming traffic on Center St. A 25 mph speed limit sign (for eastbound traffic) is installed at 854 E Center St, approximately 600 feet prior to the 1000 E intersection.

1. Resolve the clear vision issues with adjacent property owners.
2. Install yield signs for northbound and southbound traffic on 1000 E streets.

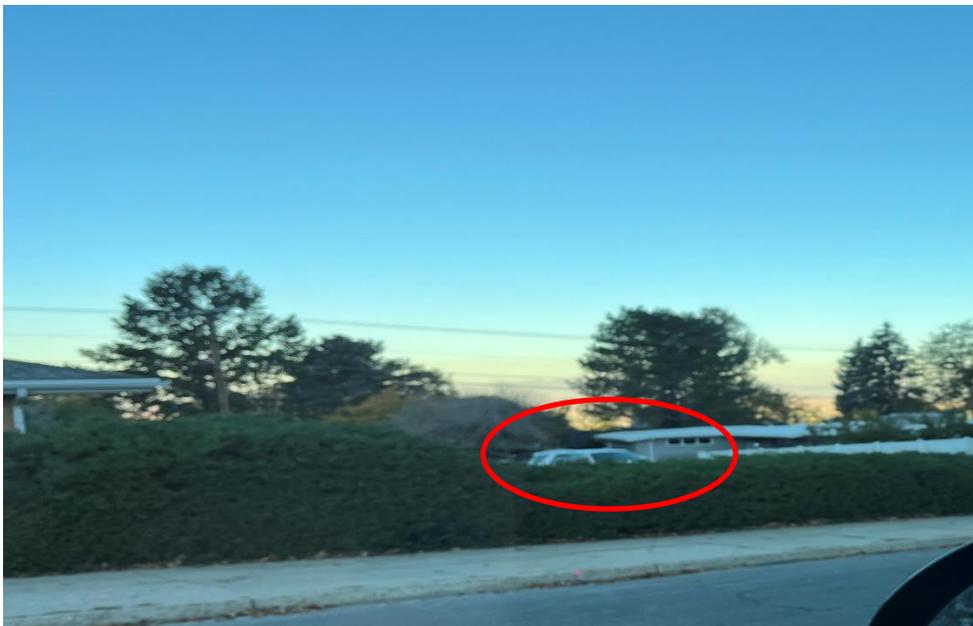
A field inspection of the intersection, conducted on the morning of 31 October, 2023 identified 2 issues that need to be addressed or the intersection to comply with 14-16-108 (C) of the Land Use Code related to Clear-View Areas:

1. 944 E Center St (SW corner of the intersection) has an overgrown Pfitzer hedge which is approximately 3 ft tall, as measured at the back of the sidewalk. This growth interferes with the identification of vehicles travelling eastbound on Center St. as shown in the photo, below:

Figure 2 Northbound View from 1000 E of Eastbound Traffic on Center St (Toyota 4 Runner, circled)

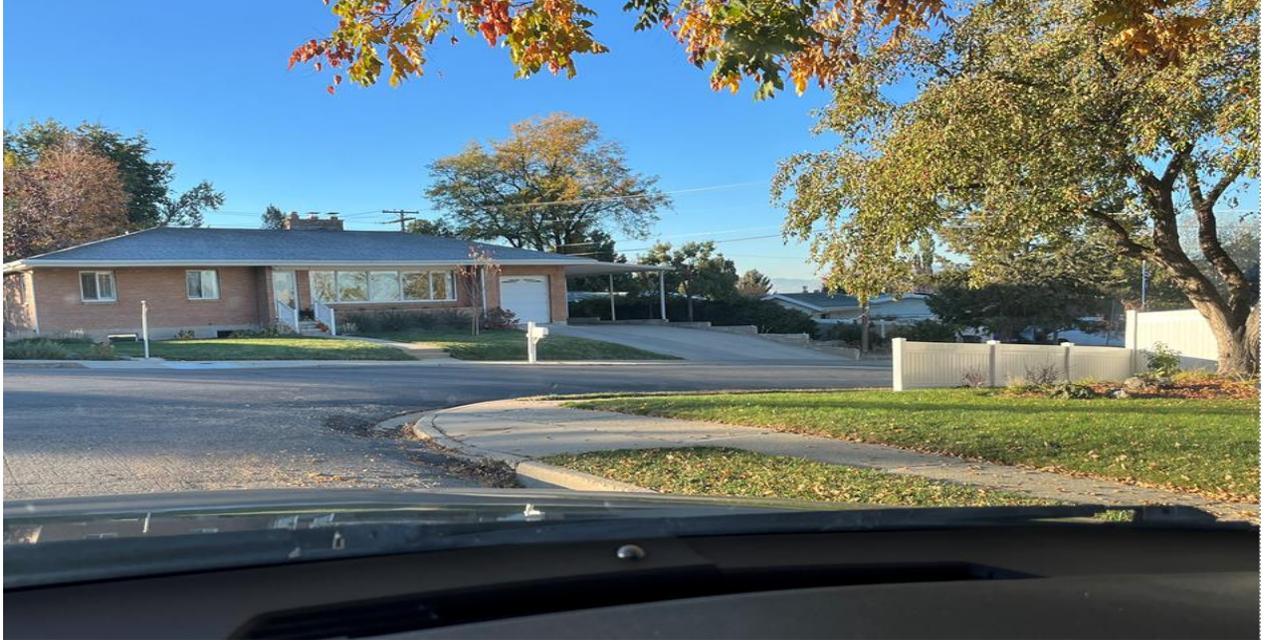
2. 13 N 1000 E (NW corner of the intersection) has installed a 3 ft tall solid fence along the Center St frontage has been constructed in the clear view area. Approximately one section of the fence encroaches. (see Figure 3)

Figure 3 Southbound View from 1000 E of Eastbound Traffic on Center St.

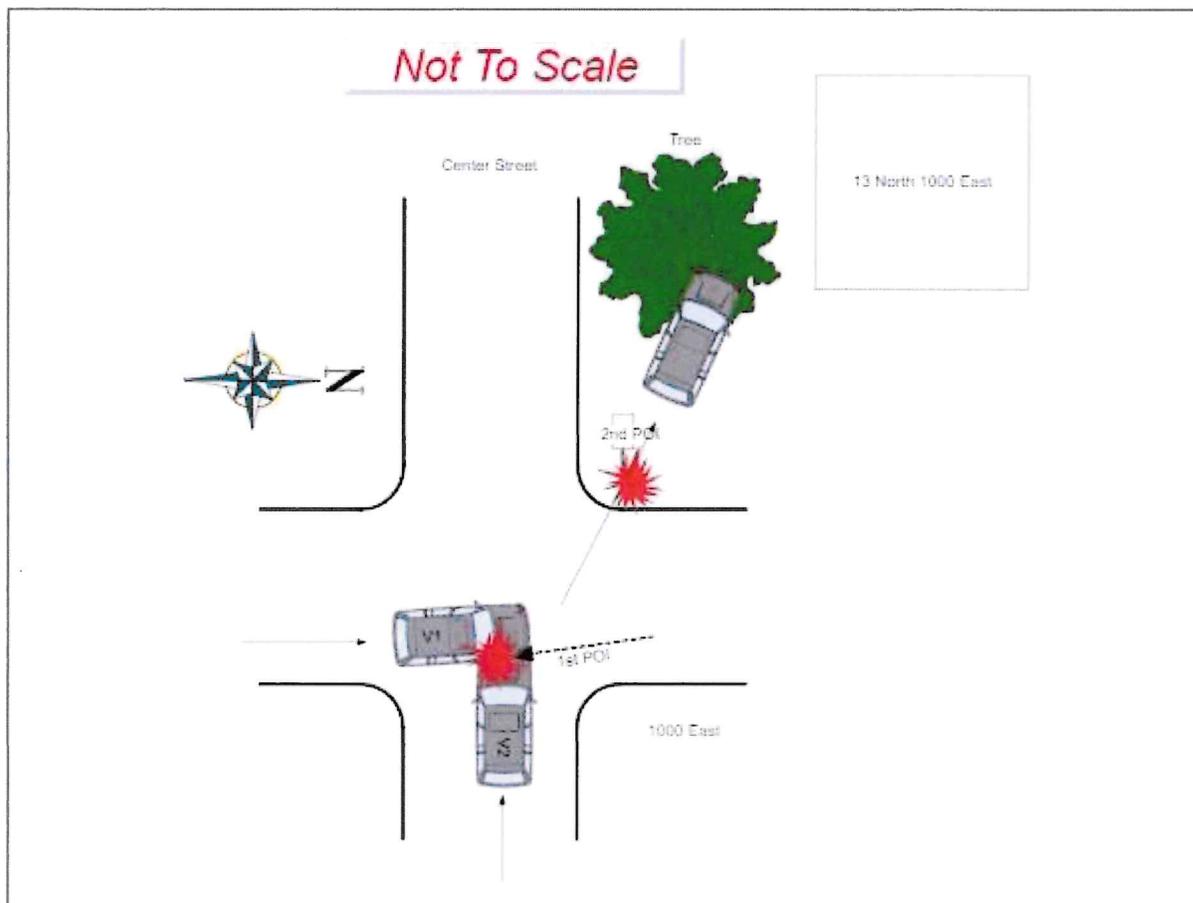
Crash Diagram

V1 (Ford) was traveling north bound on 1000 East and entered the intersection of Center Street. V2 (Honda) was traveling west bound on Center Street and entered the intersection of 1000 East. Upon entering the intersection V1 was struck by V2, front end of V2 collided into the front passenger side of V1.

The collision caused V2 to travel off the roadway and over a city street sign and end up in a yard located at 13 North 1000 East. The collision caused major damage to both vehicles, both vehicles were disabled and towed.

The intersection where the accident occurred is not regulated with traffic control devices. However, it appeared both vehicles intersection at about the same time. Utah law requires the vehicle on the left, V1, to yield the right of way to V2 which approached from the right. The operator of V1 was issued a citation for failing to yield the right of way.

It should be noted that V2 traveled over a city street sign (damaged) and at least two sprinklers (damaged) belonging to the property owner of 13 North 1000 East. The remaining portion of the sign was collected and returned to the Streets Department.

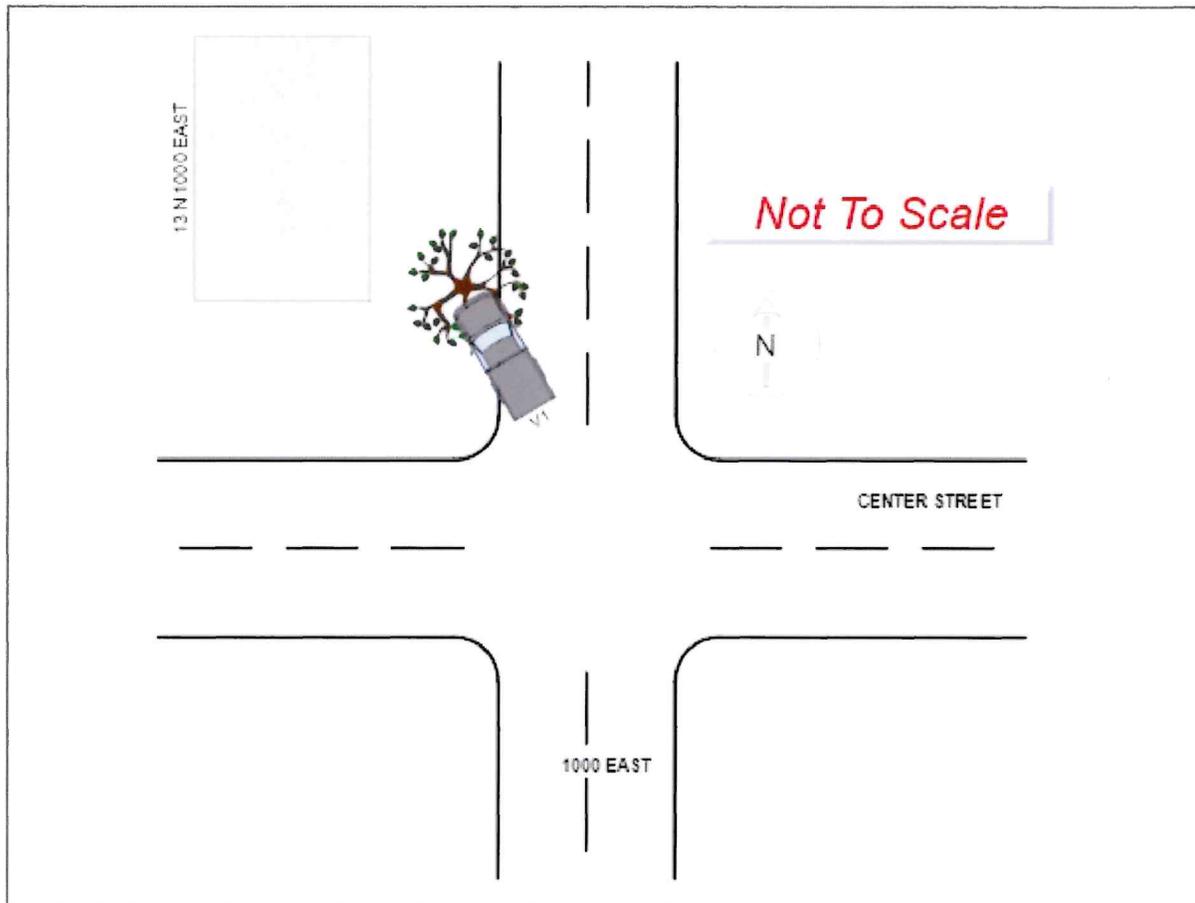
Crash Diagram

V1, a white Chevrolet Silverado, UT/W037VK, was traveling Westbound on Center Street, approaching 1000 East. V1 attempted to make a right hand turn onto 1000 East for Northbound travel. V1 was traveling too fast to safely maneuver the vehicle while conducting this turn. Witness [REDACTED] estimated V1 to be traveling about 30 mph while conducting this turn. Driver of V1 reported she was driving too fast and lost control of the vehicle. V1 ran off the roadway on the West side of the roadway and collided head on with a tree in the front yard of residence 13 N 1000 East. Driver of V1 reported injury to her knee. EMS responded to provide care for driver of V1. Driver was not transported to the hospital. Driver was the only occupant of this vehicle. Driver was released to parent, [REDACTED]. V1 recieved severe damages to the front end of the vehicle. With driver side airbag deployment. V1 was towed by Dewaal & Sons Towing. Driver of V1 recieved Citation #MV0005461

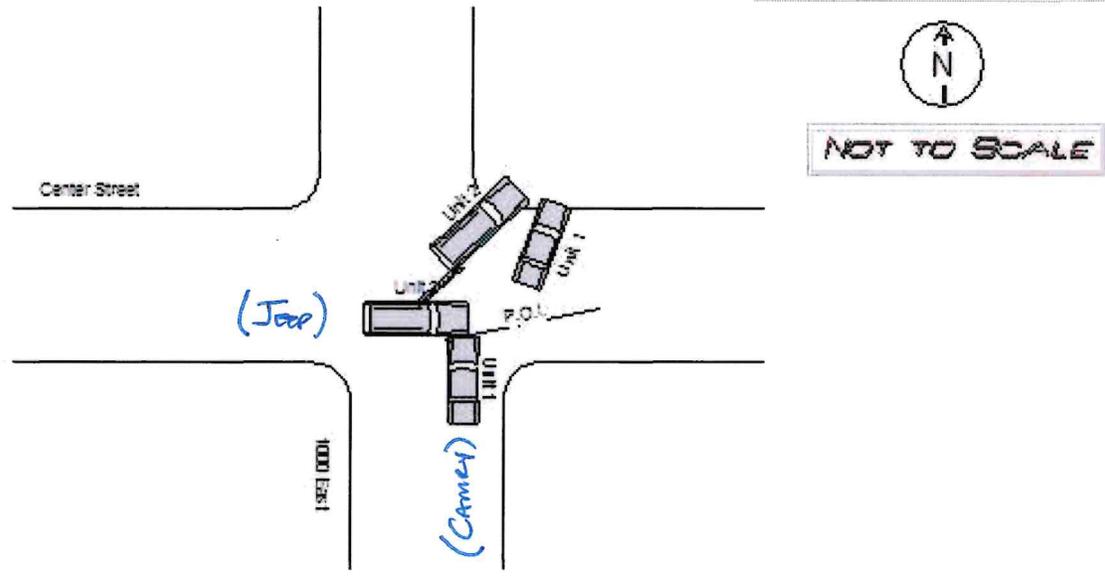
V1 (RED TOYOTA) WAS NORTHBOUND ON 1000 EAST APPROACHING THE INTERSECTION OF CENTER STREET. V2 (BLACK JEEP) WAS EASTBOUND ON CENTER STREET APPROACHING THE INTERSECTION OF 1000 EAST. BOTH VEHICLES ENTERED THE INTERSECTION AT APPROXIMATELY THE SAME TIME. AFTER IMPACT BOTH VEHICLES COLLIDED AS THEY WENT TO THE LEFT AND ENDING ON THE NORTH SIDE OF THE INTERSECTION UP AGAINST THE CURB. V1 STATED SHE WAS NORTHBOUND ON 1000 EAST AND APPROACHING THE INTERSECTION AND DID NOT SEE V2. DRIVER OF V1 STATED THERE WAS NO STOP SIGN AT THE INTERSECTION. DAMAGE TO V1 WAS TO THE FRONT BUMPER, HOOD, ENGINE COMPARTMENT AND TO THE REAR DRIVER'S SIDE PASSENGER DOOR FROM A SECOND IMPACT WITH V2. DRIVER OF V2 STATED SHE WAS EASTBOUND ON CENTER APPROACHING THE INTERSECTION OF 1000 EAST AND DID NOT SEE V1. SHE STATED IT WAS TOO LATE TO STOP BEFORE IMPACT. DAMAGE TO V2 WAS TO THE FRONT PASSENGER SIDE CORNER WITH DENTS, AND A DAMAGED WHEEL. ALL PARTIES STATED THEY WERE OK AND DID NOT NEED MEDICAL ATTENTION. FROM THE POINT OF IMPACT AND DAMAGE ON THE VEHICLES IT APPEARED AS IF V2 WAS PROBABLY THE FIRST IN THE INTERSECTION, BUT SINCE BOTH PARTIES STATED THEY DID NOT SEE EACH OTHER IT WAS UNKNOWN WHO ENTERED THE INTERSECTION FIRST, THERE WERE NO CITATIONS ISSUED.

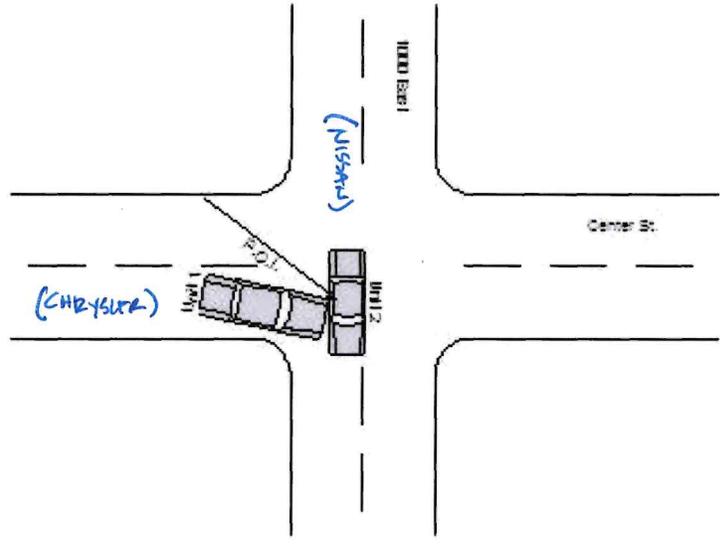
V1 (RED CHRYSLER) WAS EASTBOUND ON CENTER ST. ENTERING THE INTERSECTION OF 1000 E, WHEN V1 HIT V2 (NISSAN) AS V2 WAS EXITING THE INTERSECTION. V1 SUSTAINED DAMAGE TO THE DRIVER'S FRONT CORNER OF THE VEHICLE. V1 WAS DRIVEABLE AND RETAINED BY OWNER.

V2 WAS SOUTHBOUND ON 1000 E AND WHILE V2 WAS EXITING THE INTERSECTION WITH CENTER STREET V2 WAS STRUCK ON THE PASSENGER SIDE IN THE MIDDLE OF BOTH PASSENGER DOORS. V2 WAS DRIVEABLE AND RETAINED BY OWNER.

V1 WAS FOUND AT FAULT OF THIS CRASH. 1000 E CENTER ST. IS AN UNREGULATED INTERSECTION, V2 WAS ALREADY OCCUPYING THE INTERSECTION AND WAS ALMOST CLEAR FROM IT WHEN V1 HIT V2. THE DAMAGE AND THE DIAGRAM WILL DEPICT THE LOCATION.

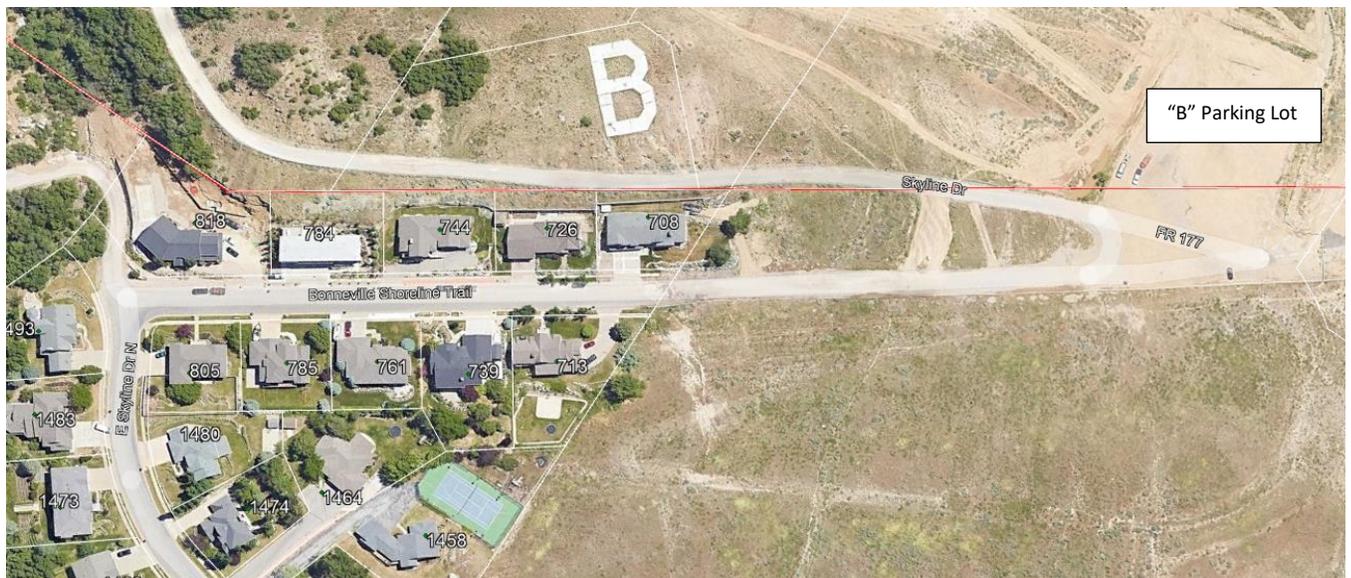
Figure 1 Eagle Ridge Drive, Skyline Drive Intersection to "B" Parking Lot

During the summer, and other high-use times of the year, recreational users use the paved section of Eagle Ridge Drive for unloading, parking and loading of their vehicles and recreational equipment. This use can encroach on resident's driveways, inhibit the pickup of garbage and restrict mail delivery. Recreational vehicles also track mud and debris from the parking area to the street.

Eagle Ridge Drive is a 54 ft wide right of way with a 30 ft pavement width. Each side of the street has a 6 ft park strip and a 4 ft wide sidewalk. No parking restrictions are currently in place in this area. On-street parking on one side of the street reduces the available width for vehicles to approximately 20 feet, which is passable for two way traffic, but requires drivers to reduce speed. When parking occurs on both sides of the street the road is reduced to a single travel lane.

The City Engineer suggests no action be taken on the request. Issues with obstructing access to the homes should be resolved with assistance from the Police Dept. Issues with the tracking of dirt, mud or debris should be brought to the attention of the Street Dept.
